## On-Lot Sewage Disposal System Inspection|PA Report

LOCATED AT:  
1855 Westwood Road, York, PA 17403

INSPECTED ON:  
7/9/2026 12:00:00 PM

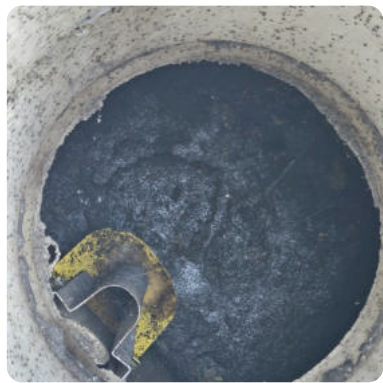
###### Abnormally Low Sewage Level Observed In Septic Tank

The sewage level within the septic tank was observed to be abnormally low at the time of inspection. Low sewage levels may indicate leakage, structural deterioration, cracks, missing drain plugs, or other tank defects depending upon the tank material and age.

**Notes :** When I opened the septic tank, I observed no effluent at the baffles; it was at the bottom of the tank. I then ran water into it, and water did enter, but the tank did not fill, which in my experience would indicate a damaged concrete tank. I was unable to see through the sludge at the bottom.

Further evaluation by a qualified specialist is recommended. Address any repairs as needed upon evaluation.

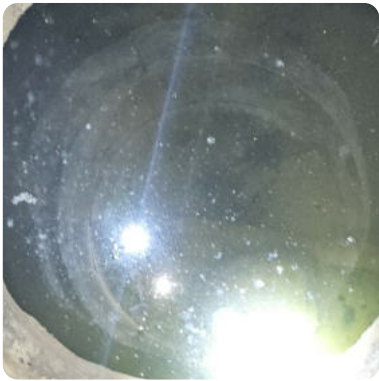
###### Abnormally Low Sewage Level Observed In Septic Tank

The sewage level within the septic tank was observed to be abnormally low at the time of inspection. Low sewage levels may indicate leakage, structural deterioration, cracks, missing drain plugs, or other tank defects depending upon the tank material and age.

**Notes :** As shown in the photo, the liquid inside the tank is clear, indicating that no effluent from the first tank is entering it, as this is not possible. Once the first tank is further evaluated and corrections are made, the second tank can be evaluated more thoroughly.

**RECOMMENDATION:**  
Further evaluation by a qualified specialist is recommended. Address any repairs as needed upon evaluation.

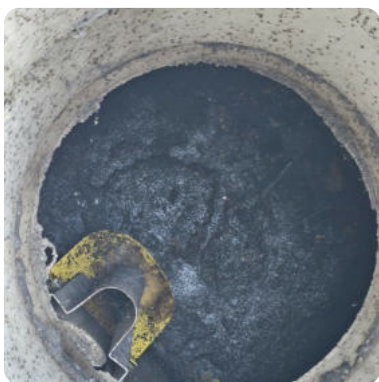
## Abnormally Low Sewage Level Observed In Septic Tank

The sewage level within the septic tank was observed to be abnormally low at the time of inspection. Low sewage levels may indicate leakage, structural deterioration, cracks, missing drain plugs, or other tank defects depending upon the tank material and age.

**Notes :** When I opened the septic tank, I observed no effluent at the baffles; it was at the bottom of the tank. I then ran water into it, and water did enter, but the tank did not fill, which in my experience would indicate a damaged concrete tank. I was unable to see through the sludge at the bottom.

Further evaluation by a qualified specialist is recommended. Address any repairs as needed upon evaluation.

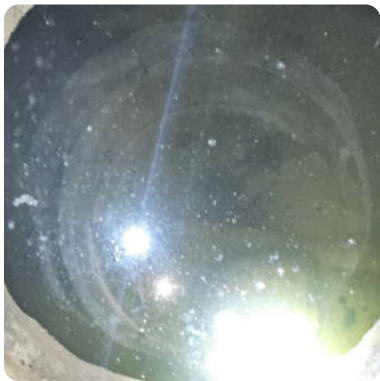
**Abnormally Low Sewage Level Observed In Septic Tank**

The sewage level within the septic tank was observed to be abnormally low at the time of inspection. Low sewage levels may indicate leakage, structural deterioration, cracks, missing drain plugs, or other tank defects depending upon the tank material and age.

**Notes :** As shown in the photo, the liquid inside the tank is clear, indicating that no effluent from the first tank is entering it, as this is not possible. Once the first tank is further evaluated and corrections are made, the second tank can be evaluated more thoroughly.

Further evaluation by a qualified specialist is recommended. Address any repairs as needed upon evaluation.

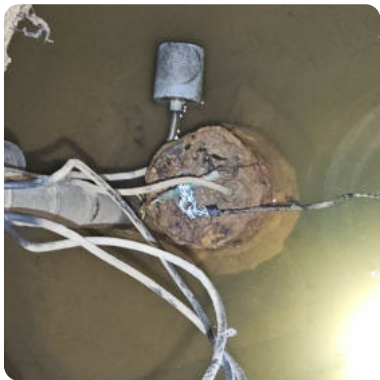
**ESM Dosing Pump Inspector's Remarks**

The dosing pump could not be inspected due to insufficient liquid in the tank, preventing it from activating. Further evaluation and necessary corrections are required before the dosing pump can be assessed for functionality.

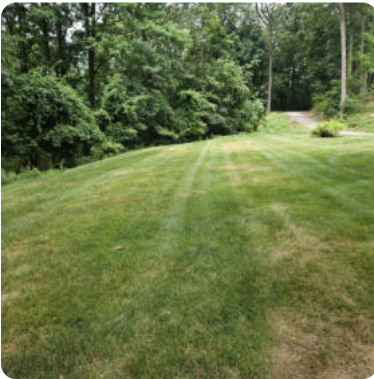
**System Conditions ESM****Lateral Cleanouts Below Grade – Unable To Inspect**

One or more lateral cleanouts associated with the elevated sand mound system were located below grade and could not be accessed or inspected at the time of inspection. Proper access to lateral cleanouts is important for maintenance, servicing, and evaluation of system conditions.

Routine maintenance is recommended. Routine maintenance includes normal upkeep such as minor repairs, adjustments, cleaning, or replacement of small components (e.g., caulking, filters, screens). These items are part of homeownership and are not considered significant defects.
