# Confidential Inspection Report

## Final Stucco Inspection Report

09/03/2026

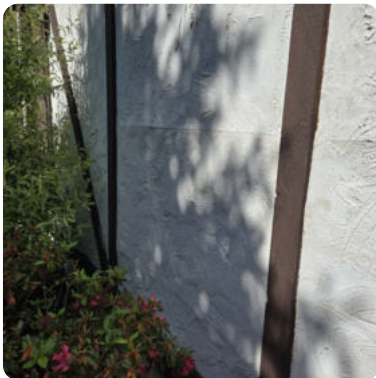
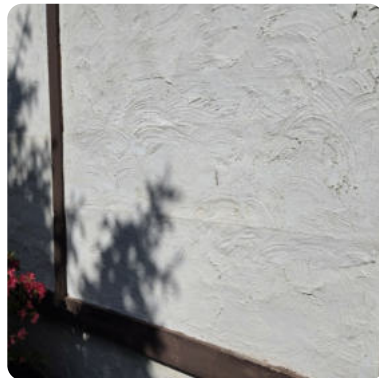
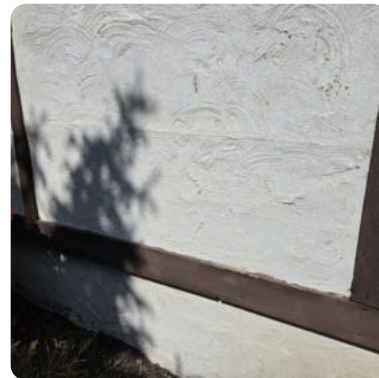
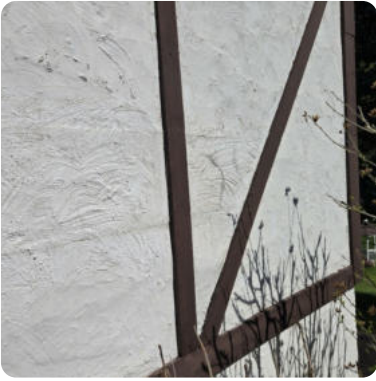
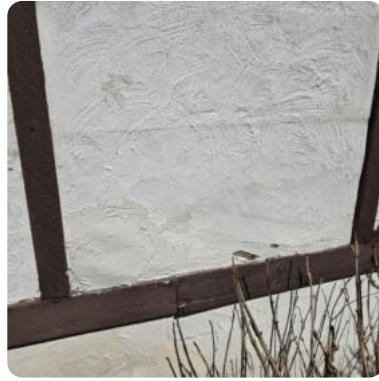
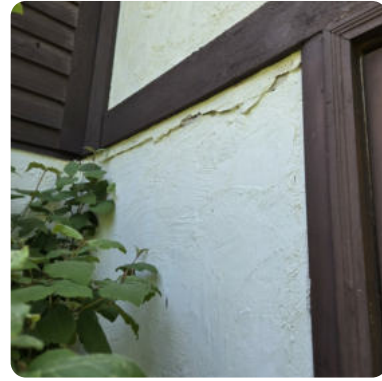
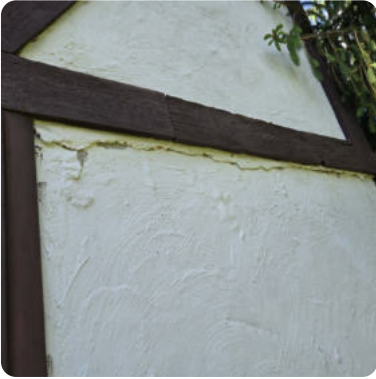
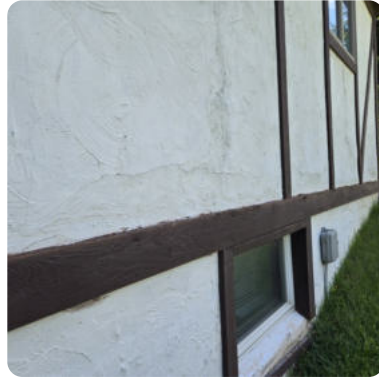
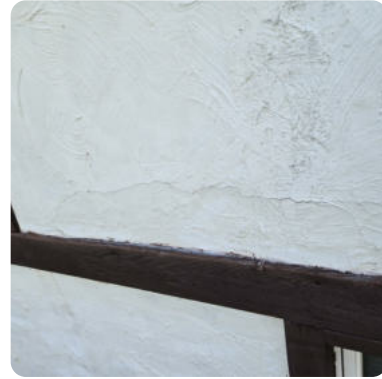
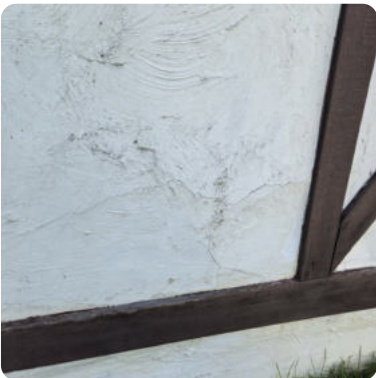
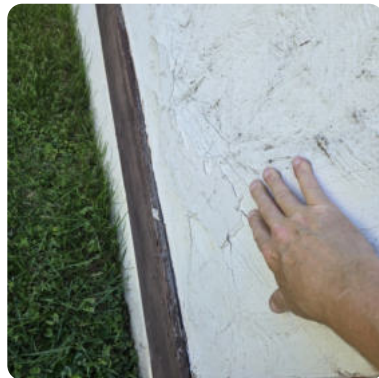
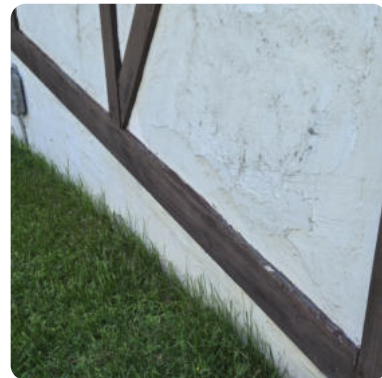
**Finish Coat Damage Observed**

It is suggested to have a qualified specialist make corrections as needed.

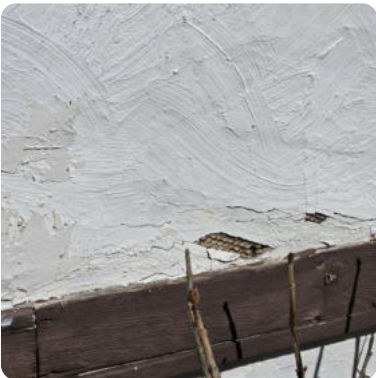
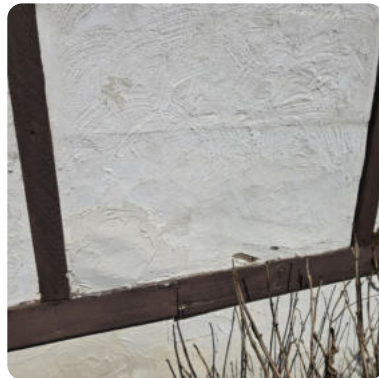
### Exposed Mesh Observed

Mesh should be fully embedded within the base coat of the system. It is suggested to have a qualified specialist further evaluate and make corrections as needed.

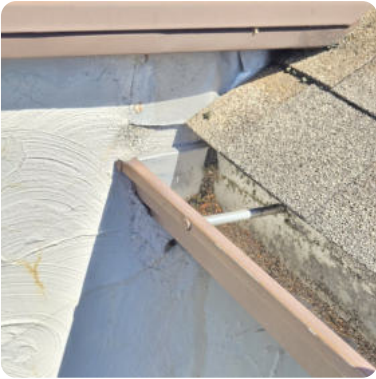
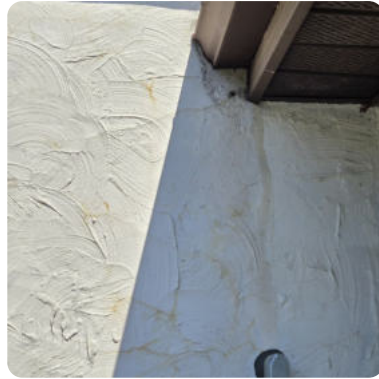
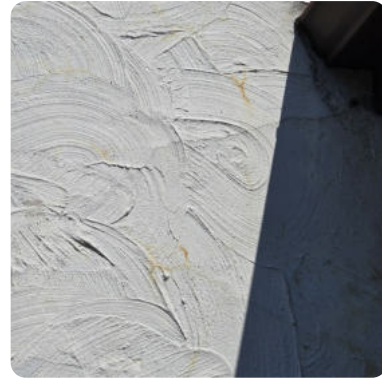
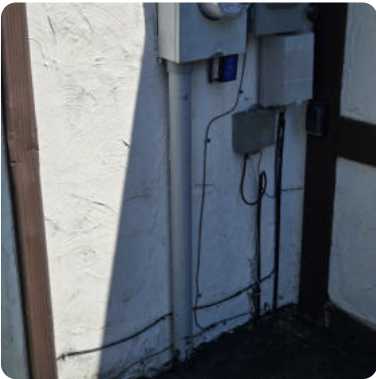
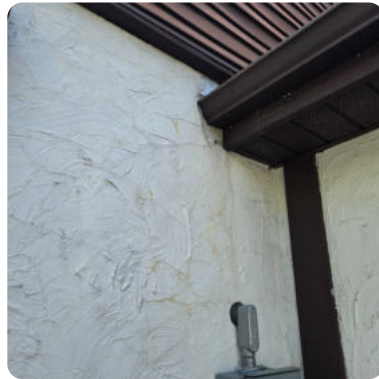
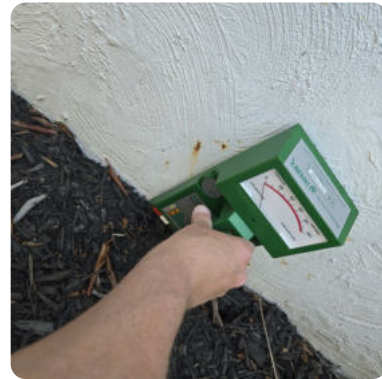
**Evidence Of Prior Repairs**

Evidence of past moisture behind system. Stains and cracking of finish coat. Rust spots from mesh rusting coming through finish coat.

It is suggested to consult with the current occupant(s) as to why and when the repairs were made. Future monitoring is suggested.

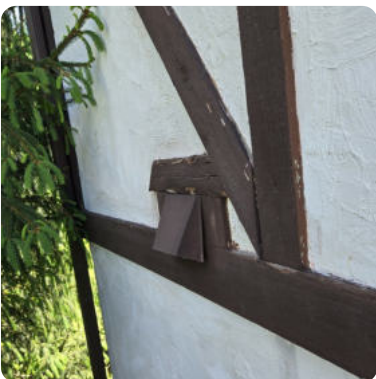
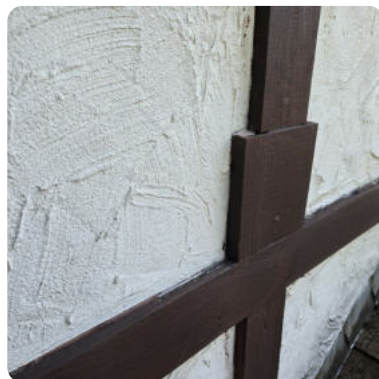
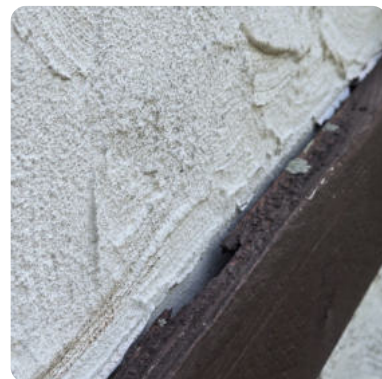
Applied wood trim installed over scratch coat, then finish coat applied between boards. Some trim boards deterioration and separation from the system. No sealant applied at transitions where trim applied.

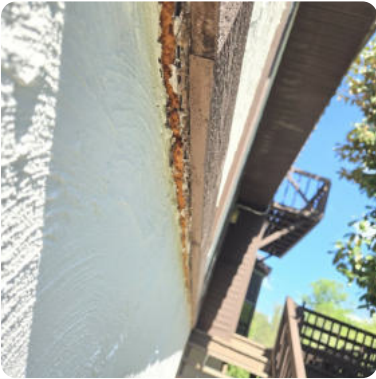
Polyisocyanurate foam board insulation backer. Exposed edge along back wall of garage, suggest sealing exposed board.

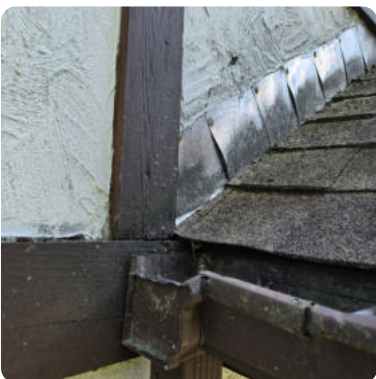
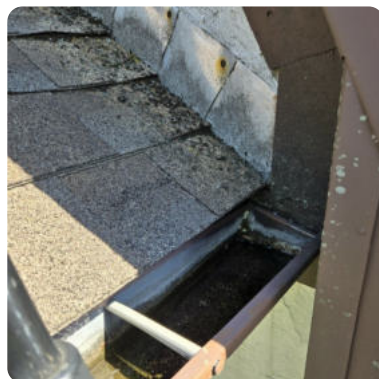
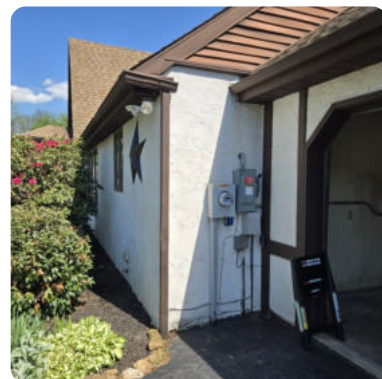
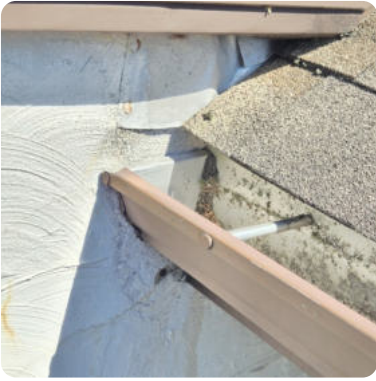
**Location:** Either side of front porch and right front over electric meter.

**Kickout Flashing(s)****Kickout Flashing Not Installed**

It is suggested to have a qualified specialist further evaluate and make corrections as needed.

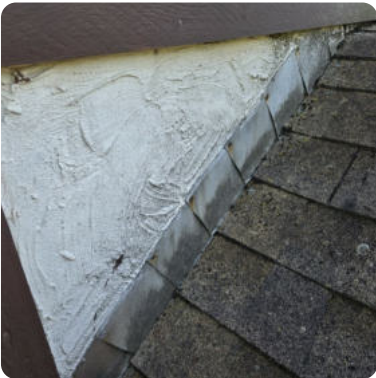
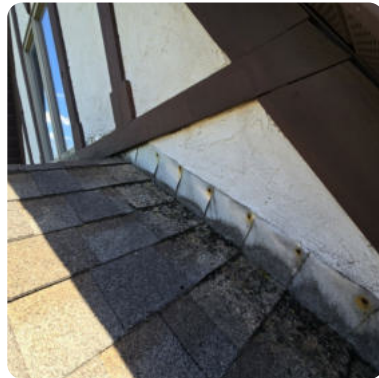
**Location: Front porch connections to house wall**

#### Roof Flashing Not Sealed

It is suggested to have a qualified specialist further evaluate and make corrections as needed.

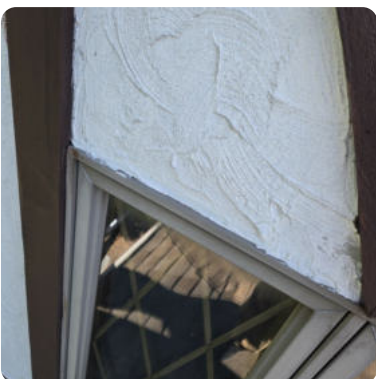
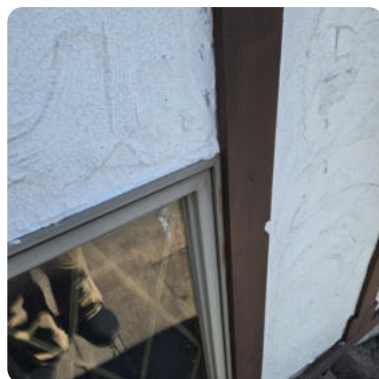
**Location: All window locations in the system**

#### Sealant Not Applied

It is suggested to have a qualified specialist make corrections as needed.

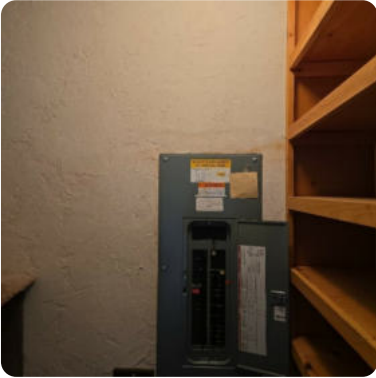
**Location: 1st Floor electrical panel closet**

**Dry Stain(s) Observed**

These stain(s) observed were scanned and found dry at the time of the inspection. Suggest consulting the current occupant(s) on their knowledge of the stain(s). Remedial repairs and monitoring are suggested if the source of the stain has been corrected.

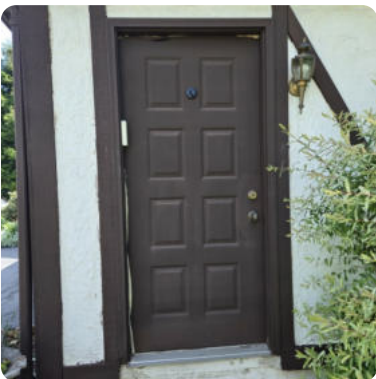
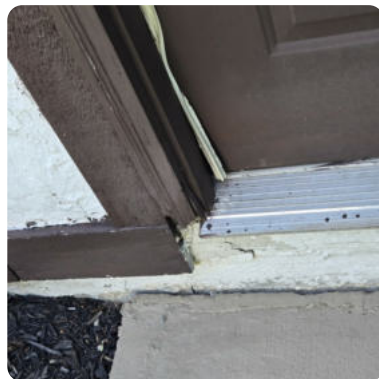
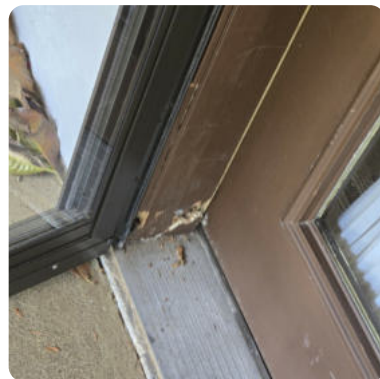
**Location: Door trim and jambs at garage side and rear doors.**

**Doors****Dry Moisture Damage Observed**

The areas affected were scanned and found dry at the time of the inspection. Suggest consulting the current occupant(s) about their knowledge of the damage. Repairs and monitoring are suggested if the source of the damage has been corrected.

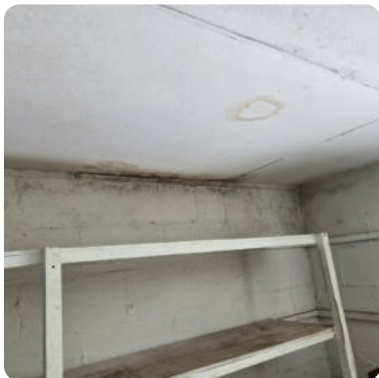
**Location: Left rear workshop**

### Dry Stain(s) Observed

These stain(s) observed were scanned and found dry at the time of the inspection. Suggest consulting the current occupant(s) on their knowledge of the stain(s). Remedial repairs and monitoring are suggested if the source of the stain has been corrected.
