## Irrigation Inspection Report

1 Total Inspectware Drive, Anywhere, USA 01234

07/12/2026

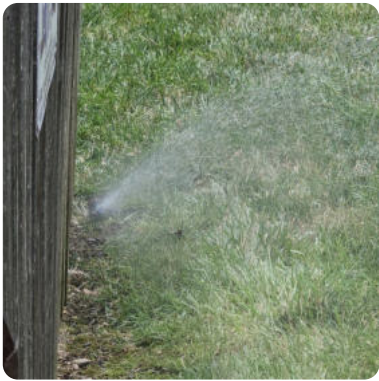
**Location:** Rear by fence

##### Vegetation Blockage Observed

Vegetation was obstructing one or more sprinkler heads. Vegetation blockage can interfere with spray patterns and reduce effective watering coverage.

**RECOMMENDATION:**  
Corrections are recommended. Repairs or replacement should be performed by a qualified specialist.

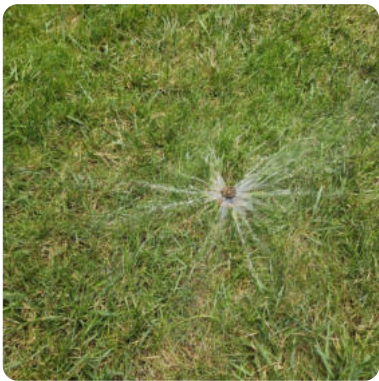
**Low Pressure and/or Flow Observed**  
Low water pressure and/or reduced water flow was observed. Low pressure conditions can lead to inadequate irrigation coverage and poor system performance.  
**Location:** Rear kitchen corner

**RECOMMENDATION:**  
Further evaluation by a qualified specialist is recommended. Address any repairs as needed upon evaluation.

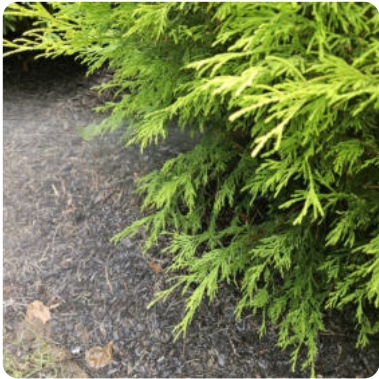
**Location: Rear deck area shrubs**

**Vegetation Blockage Observed**

Vegetation was obstructing one or more sprinkler heads. Vegetation blockage can interfere with spray patterns and reduce effective watering coverage.

Corrections are recommended. Repairs or replacement should be performed by a qualified specialist.

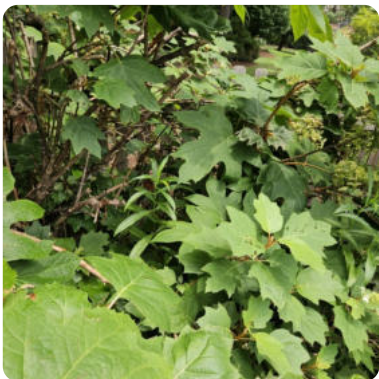
**Location: Rear corner of pool area**

**Vegetation Blockage Observed**

Vegetation was obstructing one or more sprinkler heads. Vegetation blockage can interfere with spray patterns and reduce effective watering coverage.

Corrections are recommended. Repairs or replacement should be performed by a qualified specialist.

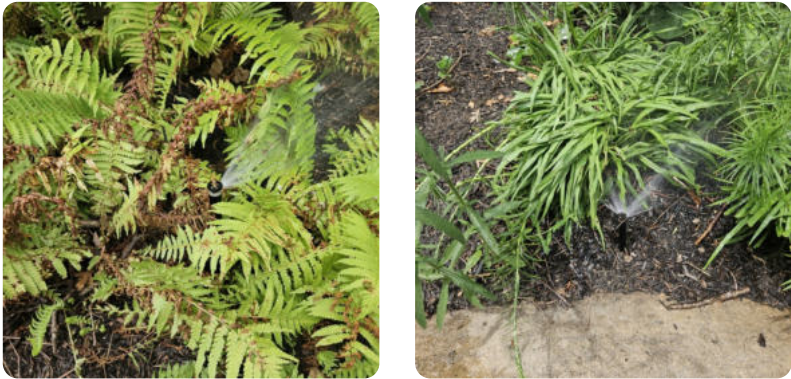
**Location:** Rear pool area along deck

**Vegetation Blockage Observed**

Vegetation was obstructing one or more sprinkler heads. Vegetation blockage can interfere with spray patterns and reduce effective watering coverage.

Corrections are recommended. Repairs or replacement should be performed by a qualified specialist.

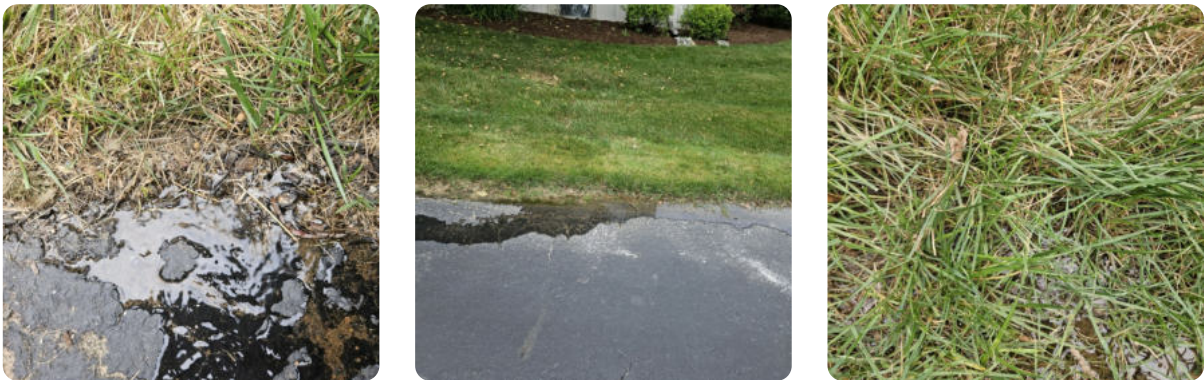
**Location:** A long driveway

**Leakage Observed**

Water leakage was observed within this irrigation zone. Leakage can increase water consumption and reduce overall system efficiency.

Further evaluation by a qualified specialist is recommended. Address any repairs as needed upon evaluation.

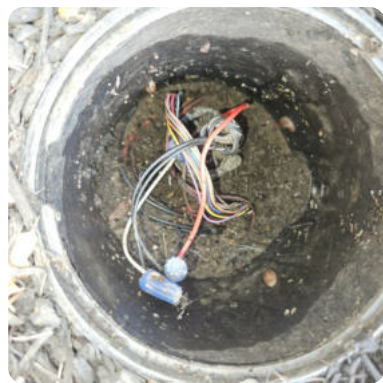
Main Irrigation Water Supply / Vacuum Breakers Condition

Satisfactory

Backflow Preventer Condition

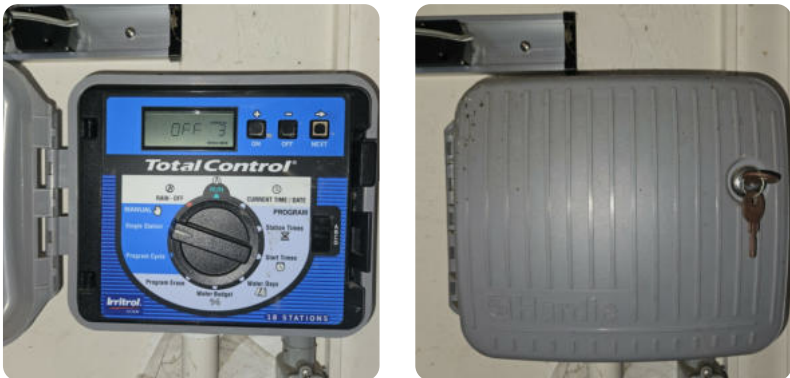
Garage

Irrigation Control Location & Condition

Functional

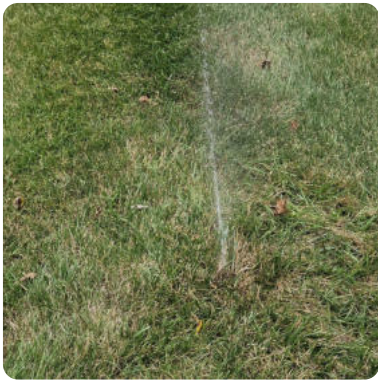
Left front corner

Functional

• Spray Rotary

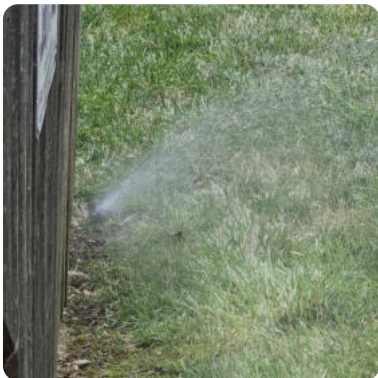
**Location:** Rear by fence

**Zone Location, Type & Condition #5****Vegetation Blockage Observed**

Vegetation was obstructing one or more sprinkler heads. Vegetation blockage can interfere with spray patterns and reduce effective watering coverage.

Corrections are recommended. Repairs or replacement should be performed by a qualified specialist.

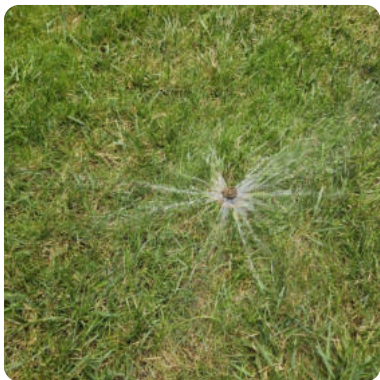
**Location:** Rear kitchen corner

**Zone Location, Type & Condition #6****Low Pressure and/or Flow Observed**

Low water pressure and/or reduced water flow was observed. Low pressure conditions can lead to inadequate irrigation coverage and poor system performance.

Further evaluation by a qualified specialist is recommended. Address any repairs as needed upon evaluation.

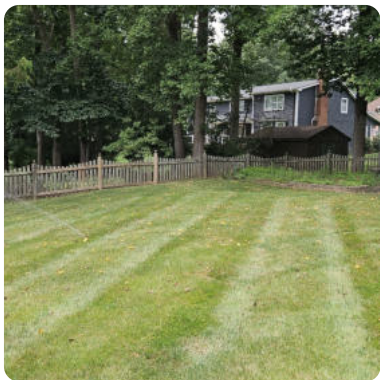
Middle rear

Functional

- Spray Rotary

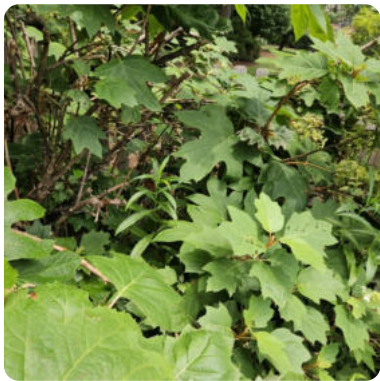
**Location:** Rear corner of pool area

**Vegetation Blockage Observed**

Vegetation was obstructing one or more sprinkler heads. Vegetation blockage can interfere with spray patterns and reduce effective watering coverage.

Corrections are recommended. Repairs or replacement should be performed by a qualified specialist.

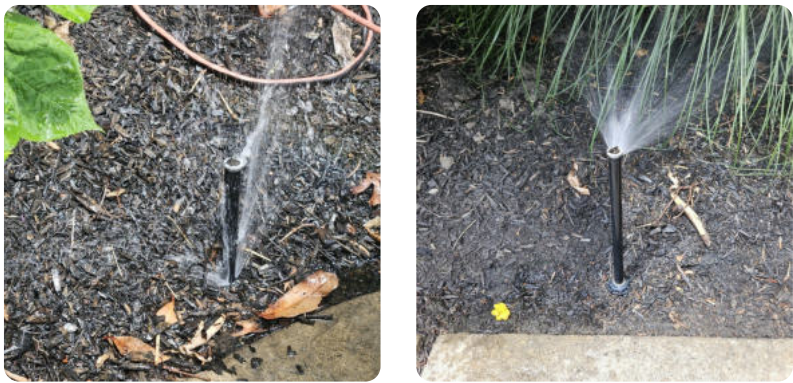
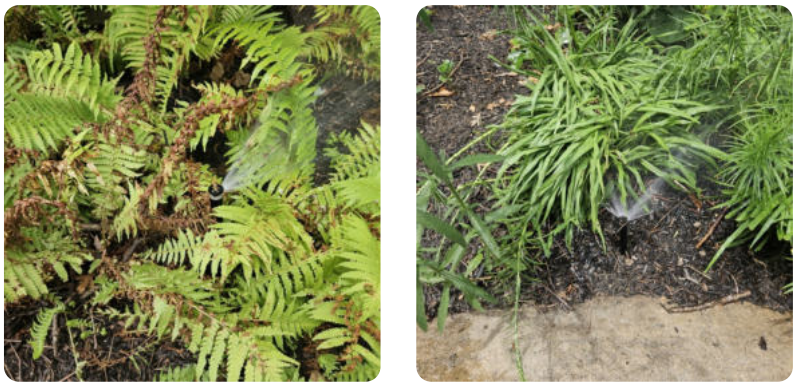
**Location: Rear pool area along deck**

**Functional**  
**Vegetation Blockage Observed**

Vegetation was obstructing one or more sprinkler heads. Vegetation blockage can interfere with spray patterns and reduce effective watering coverage.

Corrections are recommended. Repairs or replacement should be performed by a qualified specialist.

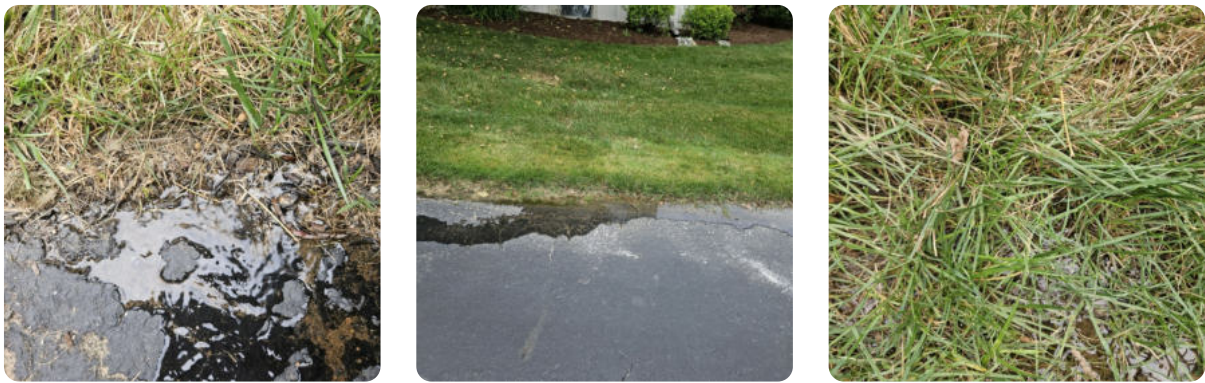
**Location: A long driveway**

**Leakage Observed**

Water leakage was observed within this irrigation zone. Leakage can increase water consumption and reduce overall system efficiency.

Further evaluation by a qualified specialist is recommended. Address any repairs as needed upon evaluation.

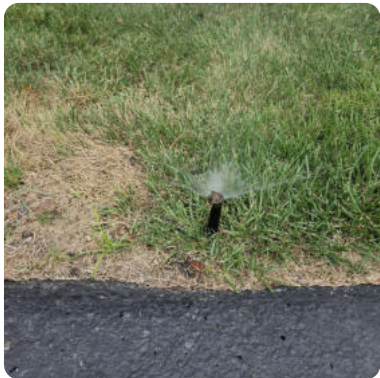
Front walkway

Functional

- Spray
