## Pool & Spa Inspection Report

1 Total Inspectware Drive, Anywhere, USA 01234

07/12/2026

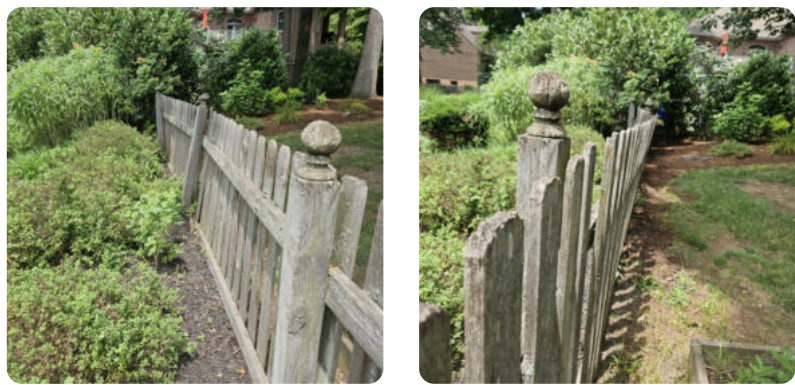
**Location:** Rear, Right, Side

#### Barrier Leaning Observed

The pool barrier was observed leaning in one or more areas. Leaning barriers may indicate movement, inadequate support, or deterioration.

#### RECOMMENDATION:

Further evaluation by a qualified specialist is recommended. Address any repairs as needed upon evaluation.

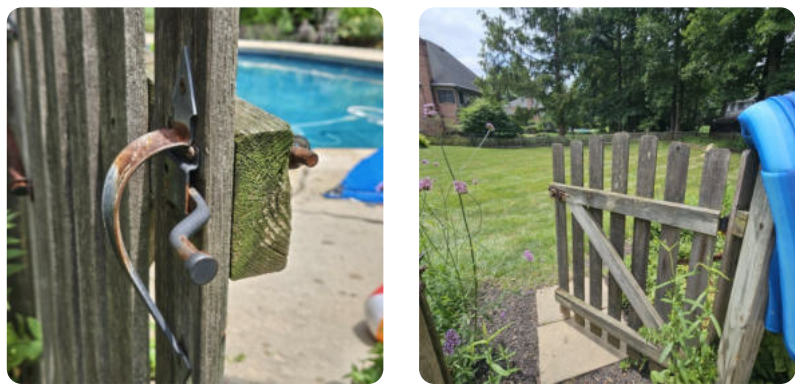
**Location:** Rear

#### Barrier Gate Not Self-Closing

**Notes :** It was also observed that the latching hardware should be replaced by a qualified specialist.

**RECOMMENDATION:**

Corrections are recommended. Repairs or replacement should be performed by a qualified specialist.

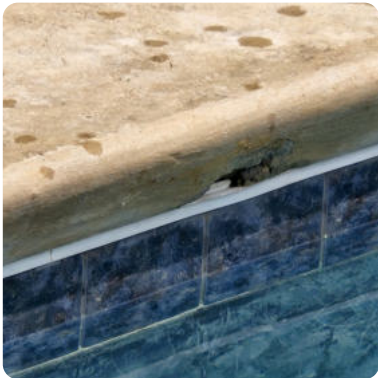
**Location: Right, Side**

**Coping Type & Condition****Coping Cracked/Damaged**

Cracking or damage was observed at the pool coping material. Damaged coping may allow water intrusion and continued deterioration.

**RECOMMENDATION:**

Corrections are recommended. Repairs or replacement should be performed by a qualified specialist.

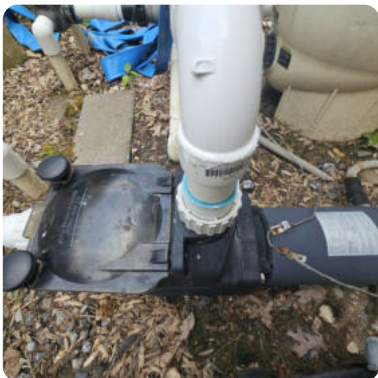
**Location: Pool equipment area**

**Pump System****Pool Pump Condition****Pool Pump Making Unusual Noise**

Unusual noise was observed during pump operation. Excessive noise may indicate worn bearings, cavitation, motor concerns, or other mechanical issues.

**RECOMMENDATION:**

Further evaluation by a qualified specialist is recommended. Address any repairs as needed upon evaluation.

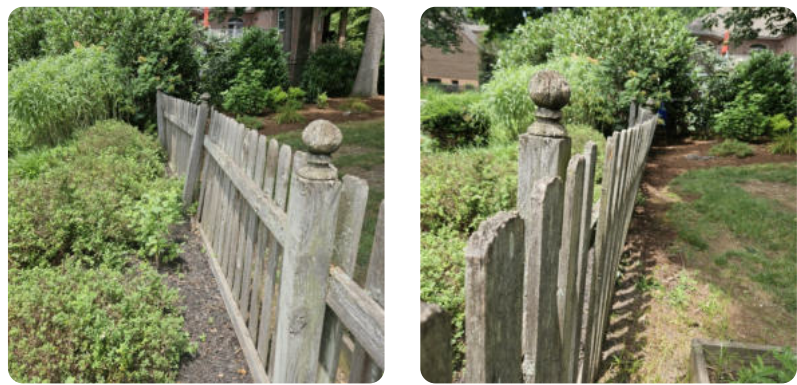
Location: Rear, Right, Side

Barrier Leaning Observed

The pool barrier was observed leaning in one or more areas. Leaning barriers may indicate movement, inadequate support, or deterioration.

RECOMMENDATION

Further evaluation by a qualified specialist is recommended. Address any repairs as needed upon evaluation.

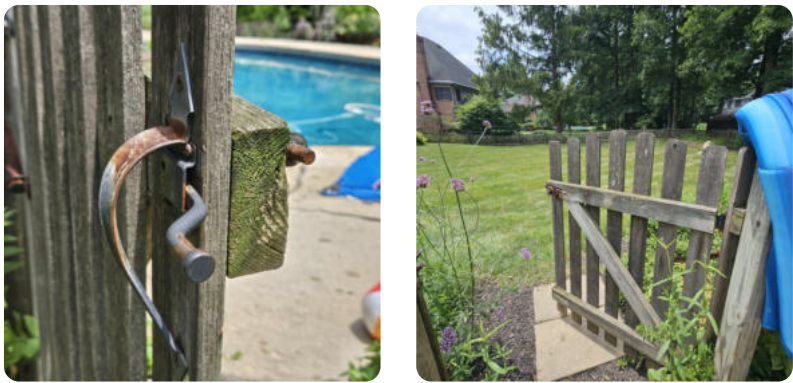
Location: Rear

Barrier Gate Not Self-Closing

Notes : It was also observed that the latching hardware should be replaced by a qualified specialist.

RECOMMENDATION

Corrections are recommended. Repairs or replacement should be performed by a qualified specialist.

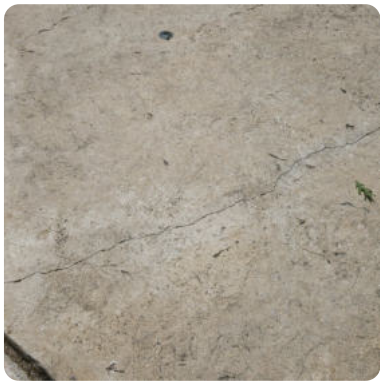
Location: Left, Side

Cracks Observed In Decking Surface

Cracking was observed at portions of the pool decking surface. Cracking may allow moisture intrusion and could worsen over time depending on movement and environmental conditions.

RECOMMENDATION

Monitor the condition and address if performance declines or conditions change.

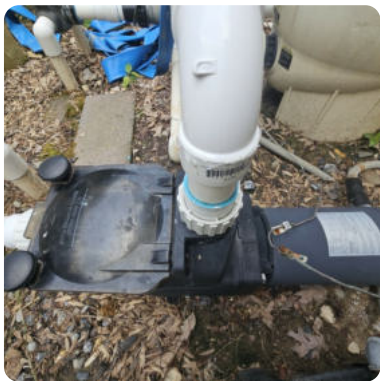
Location: Pool equipment area

Pool Pump Making Unusual Noise

Unusual noise was observed during pump operation. Excessive noise may indicate worn bearings, cavitation, motor concerns, or other mechanical issues.

RECOMMENDATION

Further evaluation by a qualified specialist is recommended. Address any repairs as needed upon evaluation.

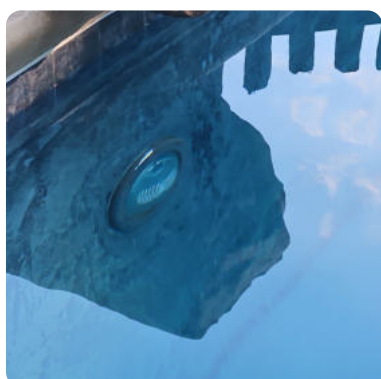
**Pool Lighting/Transformer Manufacturer****Type : Jandy****Pool Lighting/Transformer Type****Type : Surface-Mounted Light****Pool Lighting/Transformer Inspector's Remarks**

The timed intermittent lighting color change did not function when the light was activated. It is recommended to have this evaluated by a qualified specialist for necessary corrections.
