# Confidential Inspection Report

## Pre-Slab Inspection Report

1 Key Biscayne Blvd. Miami FL 33143

09/06/2026

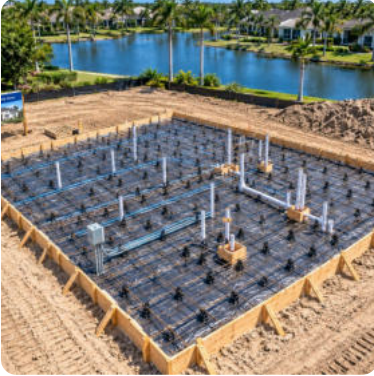
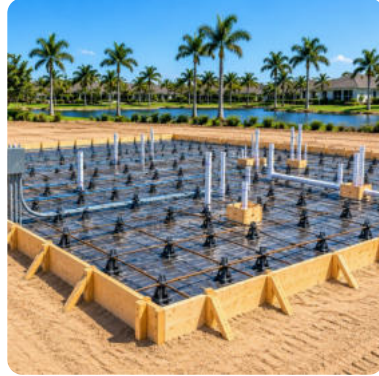
**SITE PREPARATION PHOTO GALLERY** (These photos are provided as a visual overview of site conditions and the construction layout at the time of the inspection.)

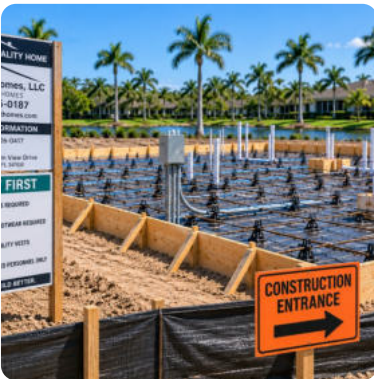
### Appropriate Signage Present

- Yes

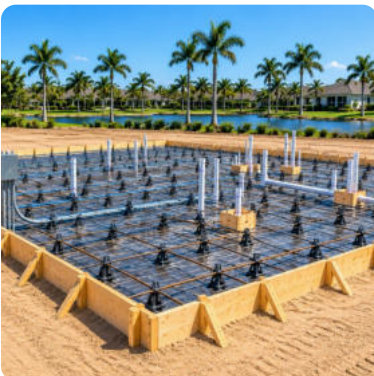
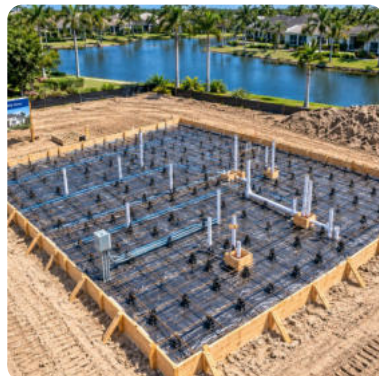
### Site Cleared and Free of Debris

- Yes. Site preparation areas associated with the planned slab were generally clear of debris and materials that could interfere with foundation preparation or concrete placement.

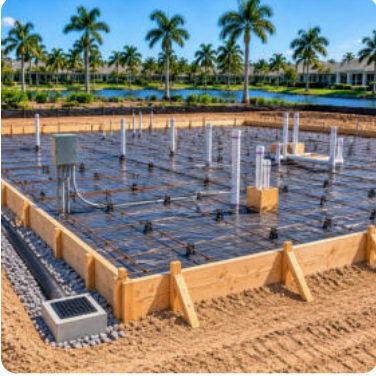
## Site Grading and Drainage

- Visible grading and drainage conditions at the foundation preparation area were satisfactory at the time of the inspection, with no significant standing water, erosion, or drainage concerns observed.

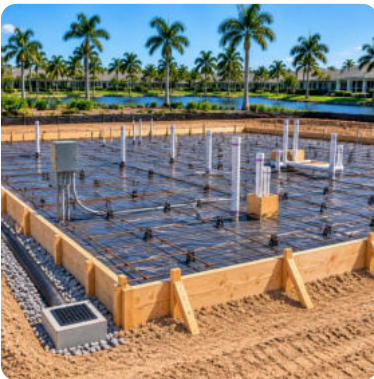
### Drainage/Foundation Preparation

- Visible foundation preparation areas were generally free of standing water, significant erosion, and other conditions that could interfere with concrete placement at the time of the inspection.

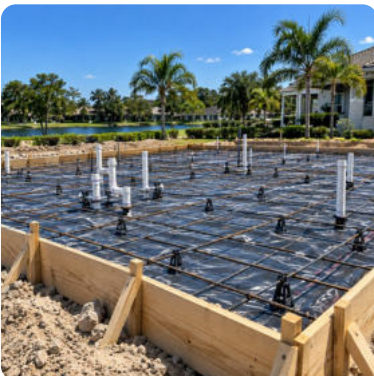
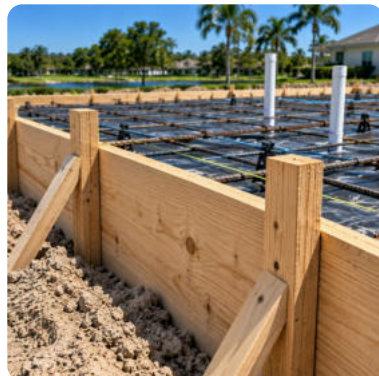
### Form Boards

- Visible form boards were generally aligned, secured, adequately braced, and configured for the planned concrete placement at the time of the inspection.

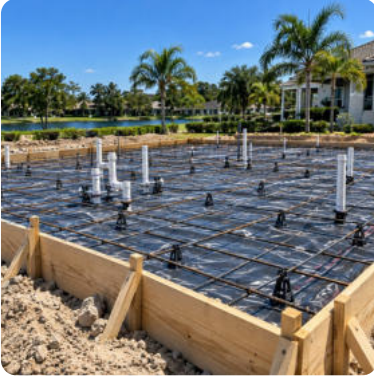
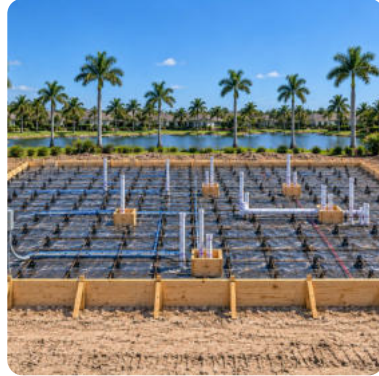
## Vapor Barrier

- The visible vapor barrier was generally continuous, properly positioned beneath the slab area, and free of significant damage at observed locations at the time of the inspection.

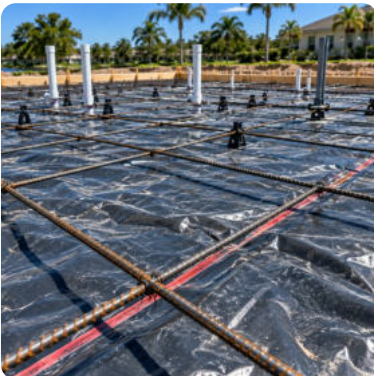
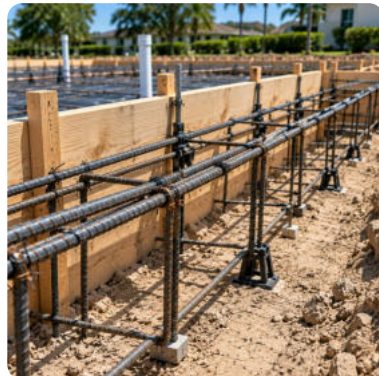
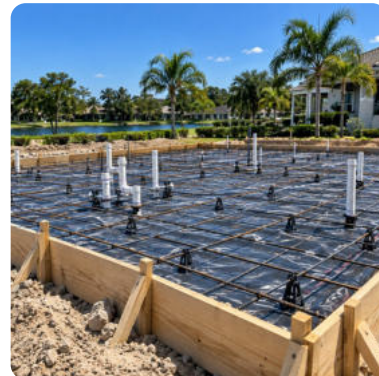
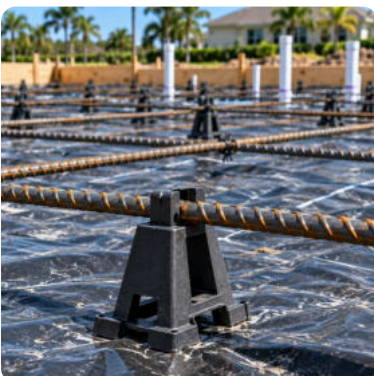
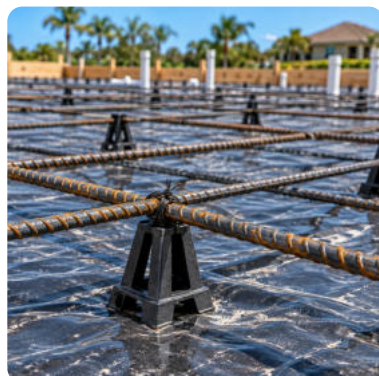
## Rebar

- Visible reinforcing steel was generally positioned, supported, and installed consistent with the available construction drawings at the time of the inspection.

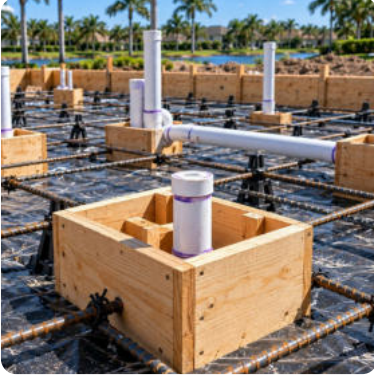
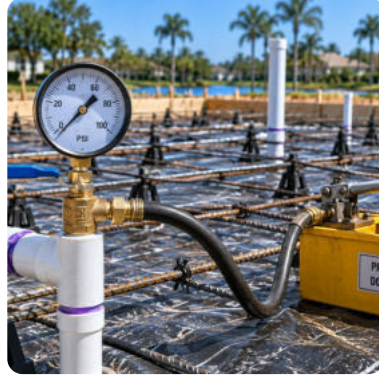
## Plumbing

- Visible under-slab plumbing components were generally positioned, supported, protected, and installed consistent with the available construction drawings at the time of the inspection.

The plumbing system was under pressure test at the time of the inspection.

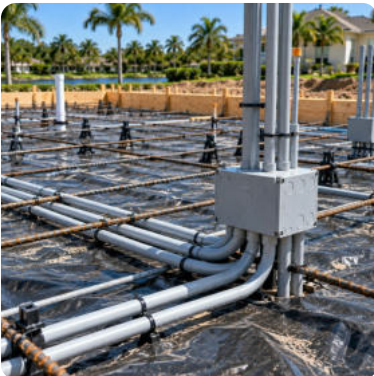
## Electrical

- Visible under-slab electrical conduit and stub-ups were generally positioned, secured, and protected consistent with the available construction drawings at the time of the inspection.
