## Residential Property Inspection|PA Report

LOCATED AT:  
6130 Poplar Path, Elizabethtown, PA 17022

INSPECTED ON:  
6/25/2026 09:00:00 AM

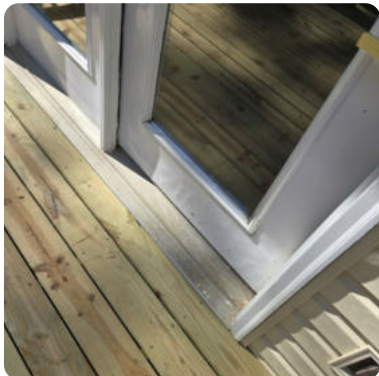
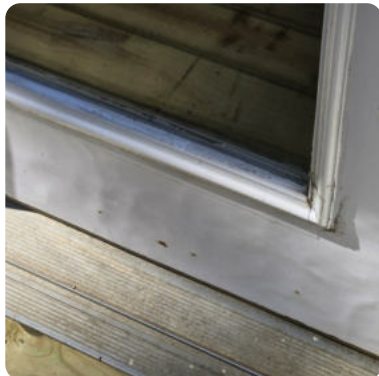
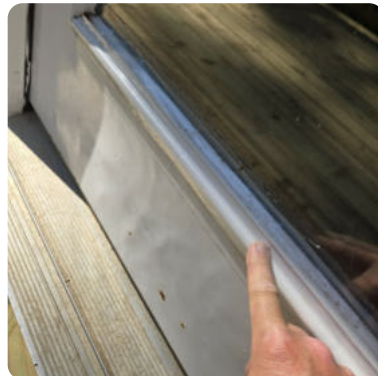
**Entry Door Damaged****Location: Rear**

**Notes :** Moisture appears to be entering around the trim, causing core damage and some rusting. Further evaluation and corrections are suggested.

**RECOMMENDATION**

Corrections are recommended. Repairs or replacement should be performed by a qualified specialist.

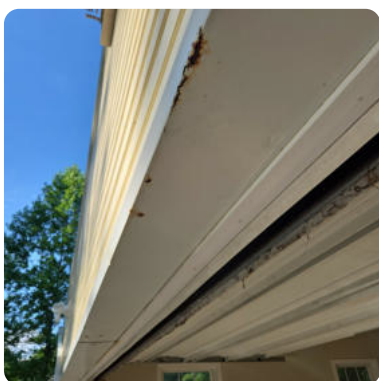
**Exterior Door Inspector's Remarks**

The garage vehicle door jamb is improperly flashed and capped, allowing water intrusion. Visible deterioration and rust corrosion are present on the capping material. Further evaluation and corrections by a qualified specialist are recommended.

RECOMMENDATION

Corrections are recommended. Repairs or replacement should be performed by a qualified specialist.

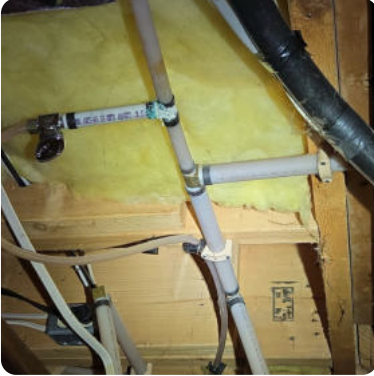
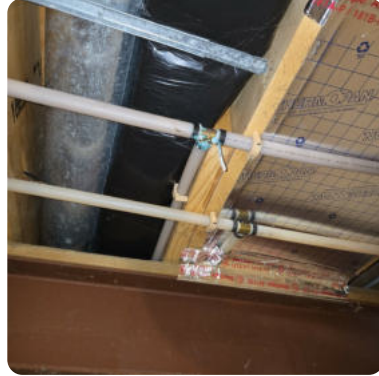
### Moderate Water Supply Pipe Rust & Corrosion Observed

Moderate rust and corrosion were observed on portions of the water supply piping. While no active leaks were noted at the time of inspection, the condition indicates ongoing deterioration that may affect pipe integrity over time. Future repairs and/or replacement should be anticipated.

### RECOMMENDATION

Monitor this condition and address if changes occur.
