## Photovoltaic Solar System Inspection Report

1 Total Inspectware Drive, Anywhere, USA 01234

09/03/2026

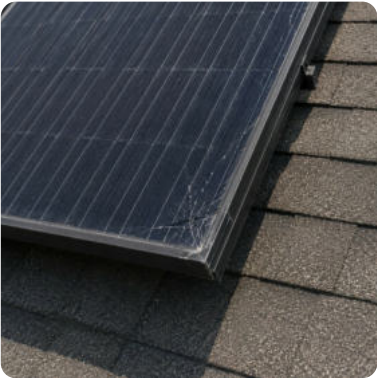
**Location:** Rear, Right, Corner

**Damaged Photovoltaic Module(s) Observed**

One or more photovoltaic modules exhibited visible damage such as cracked glass, impact damage, frame damage, or other physical deterioration. Damaged modules can reduce production and affect long-term reliability.

**RECOMMENDATION:**

Corrections are recommended. Repairs or replacement should be performed by a qualified specialist.

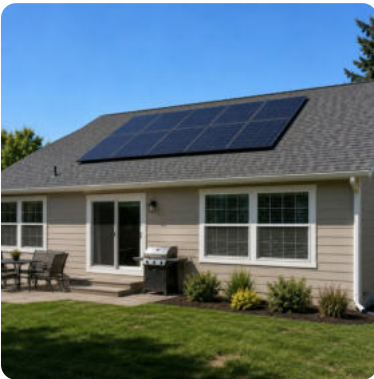
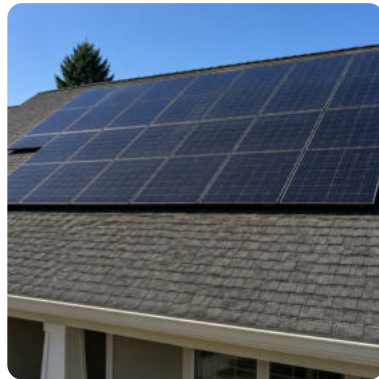
### Roof

- The visible roof covering, flashing, penetrations, and mounting locations beneath and around the solar array were found to be satisfactory at the time of inspection.
- No visible evidence of roof leaks, moisture intrusion, or failed sealants was observed beneath or adjacent to the solar array at the time of inspection.
- No visible evidence of structural sagging or damage to accessible roof framing members supporting the solar array was observed at the time of inspection.

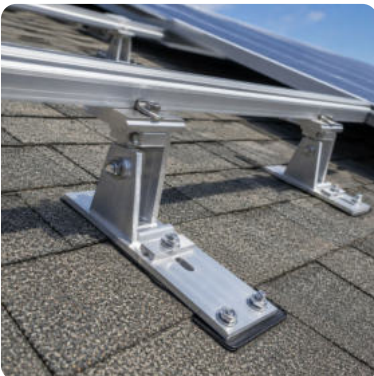
### Photovoltaic Solar Mounting

- The visible mounting hardware appeared securely fastened and free of significant corrosion at the time of inspection.
- Adequate visible clearance for ventilation beneath the photovoltaic modules was observed.

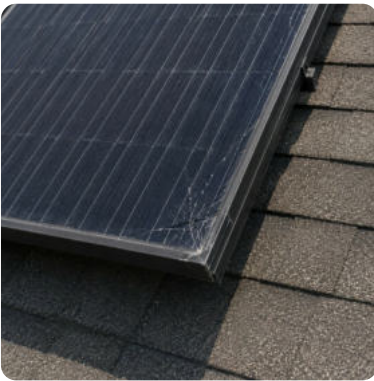
**Location:** Rear, Right, Corner

### Damaged Photovoltaic Module(s) Observed

One or more photovoltaic modules exhibited visible damage such as cracked glass, impact damage, frame damage, or other physical deterioration. Damaged modules can reduce production and affect long-term reliability.

### RECOMMENDATION

Corrections are recommended. Repairs or replacement should be performed by a qualified specialist.

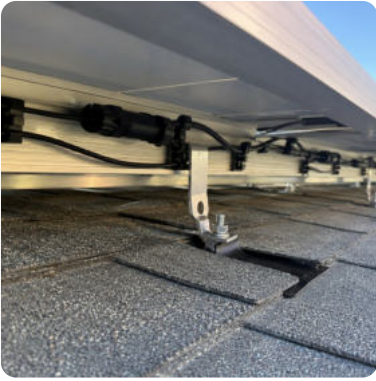
### Electrical Wiring

- The visible photovoltaic wiring appeared properly secured, protected, and clear of sharp edges or abrasive surfaces at the time of inspection.
- No exposed conductors or visibly damaged insulation were observed in the accessible areas inspected.
- The visible weatherproof fittings and exterior electrical connections appeared intact at the time of inspection.
- The visible solar circuit breakers appeared properly installed, and no double-tapped conductors were observed at the accessible equipment inspected.
- The visible wiring beneath the photovoltaic modules appeared supported and suitable for exterior exposure where observed.

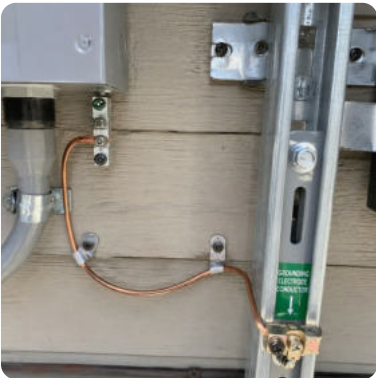
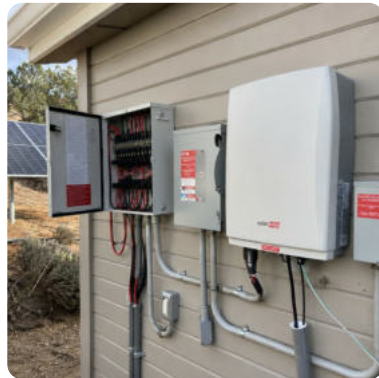
### Overcurrent Protection

- Visible overcurrent protection devices appeared present and accessible at the time of inspection.
- Accessible breakers, fuses, and combiner equipment appeared labeled and free of visible damage where inspected.

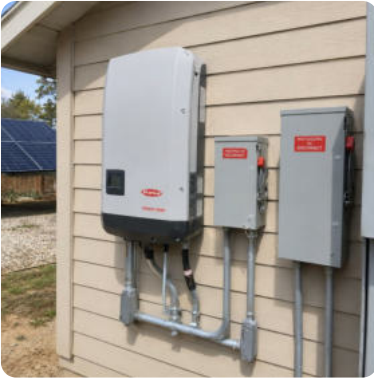
### Inverters & Disconnects

- The inverter was accessible and appeared to have adequate ventilation clearance at the time of inspection.

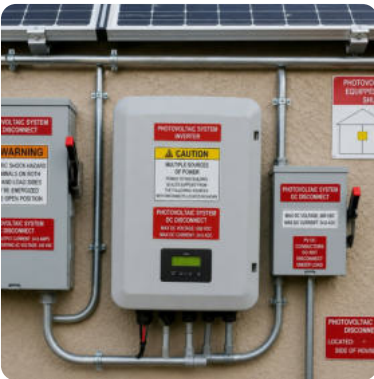
### Labeling & Identification

- The visible exterior and interior disconnects were clearly labeled and accessible at the time of inspection.
- Required visible labeling for AC/DC disconnects and inverter identification was observed at the accessible equipment inspected.

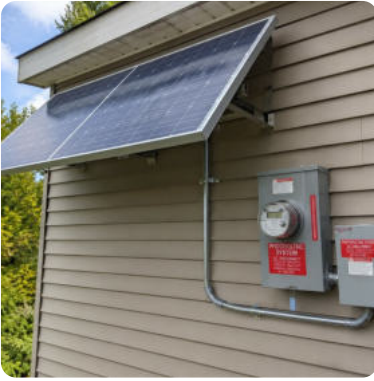
### Safety Devices & Utility Interconnection

- The utility meter and related solar equipment labeling were observed where accessible.
- System shutoff labeling was observed at the accessible service equipment and disconnects.
- Visible warning labels for photovoltaic hazards, disconnects, and rapid shutdown were observed where accessible.
- The presence of rapid shutdown equipment was visually verified where accessible.

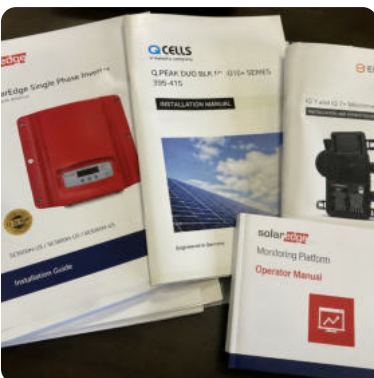
## Owner Documentation & Education

- Available operating manuals, warranty information, and installer contact information were reviewed when provided.
- The location of disconnects and basic shutoff procedures were reviewed with the current occupant when available.
- Visible maintenance considerations, such as panel cleaning or tree trimming, were documented when observed.
