## Residential Property Inspection|TX Report

3402 Cameo Drive, Houston, TX 77080

07/08/2026

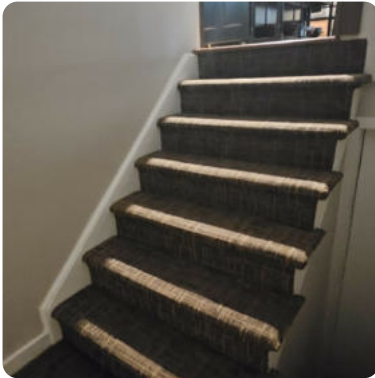
**Location: Basement**

##### Handrail(s) Not Installed

If the stairway is less than 44 inches wide and is enclosed on both sides, only one handrail is required, and if one side is open, only a railing on the open side is required. If both sides are open, standard railing components are required on both sides.

This condition presents a potential safety concern and should be addressed by a qualified specialist.

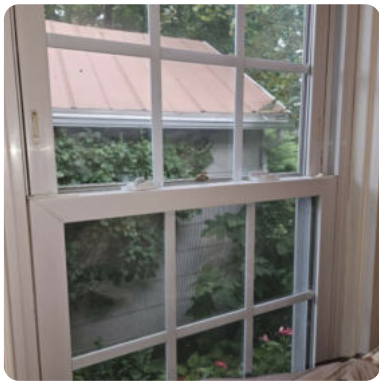
**Location: Family Room, Dining Room, Laundry**

##### IGU (Insulated Glass Unit) Failure Observed

Although double-paned & triple-paned windows appear to be stable, they actually experience a daily cycle of expansion and contraction caused by thermal pumping. Sunlight heats the airspace between the panes and causes the gas there to heat up and expand, pressurizing the space between the panes. At night, the window cools and the space between the panes contracts. This motion acts like the bellows of a forge and is called thermal pumping. Over time, the constant pressure fluctuations caused by thermal pumping will stress the seal. Eventually, the seal will develop small fractures that will slowly grow in size, allowing increasing amounts of infiltration and exfiltration of air from the space between the panes.

Corrections are recommended. Repairs or replacement should be performed by a qualified specialist.

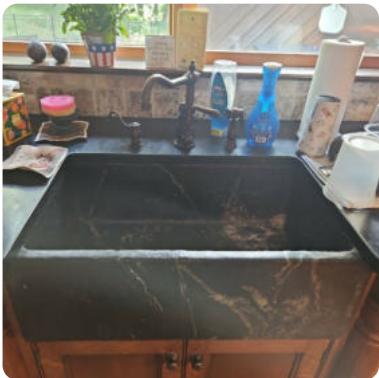
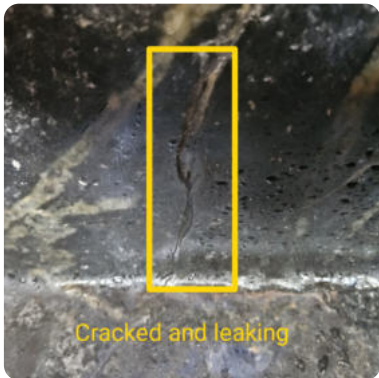
**Sink General Condition**

**Sink Damage Observed**

Corrections are recommended. Repairs or replacement should be performed by a qualified specialist.

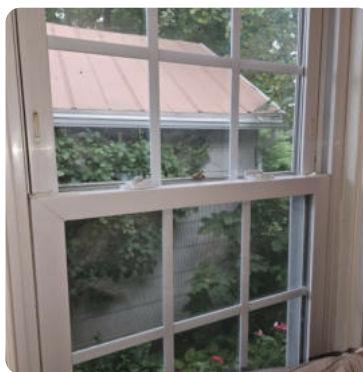
**Location: Family Room, Dining Room, Laundry**

### IGU (Insulated Glass Unit) Failure Observed

Although double-paned & triple-paned windows appear to be stable, they actually experience a daily cycle of expansion and contraction caused by thermal pumping. Sunlight heats the airspace between the panes and causes the gas there to heat up and expand, pressurizing the space between the panes. At night, the window cools and the space between the panes contracts. This motion acts like the bellows of a forge and is called thermal pumping. Over time, the constant pressure fluctuations caused by thermal pumping will stress the seal. Eventually, the seal will develop small fractures that will slowly grow in size, allowing increasing amounts of infiltration and exfiltration of air from the space between the panes.

Corrections are recommended. Repairs or replacement should be performed by a qualified specialist.

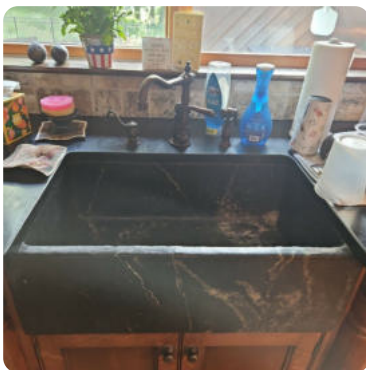
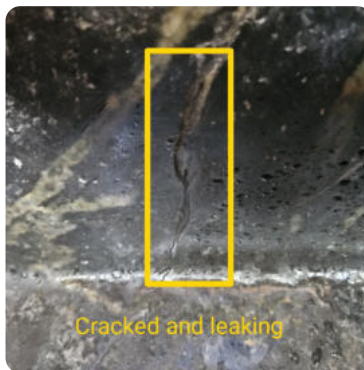
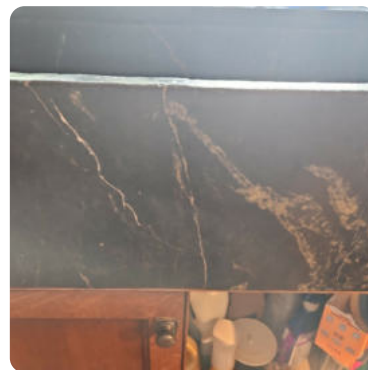
#### Sink General Condition

#### Sink Damage Observed

Corrections are recommended. Repairs or replacement should be performed by a qualified specialist.
