# Confidential Inspection Report

## Wind Mitigation|FL Report

1 Key Biscayne Blvd. Miami, FL 33143

## Uniform Mitigation Verification Inspection Form

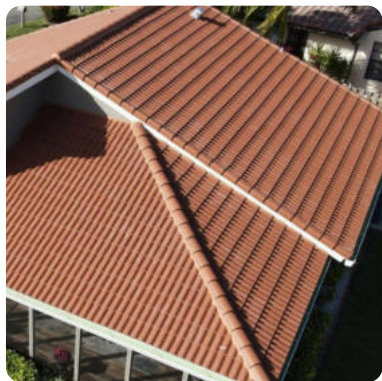
Roof Slope Photo(s)

☐ Greater than or equal to (≥ 6:12) ☒ Less than (< 6:12).

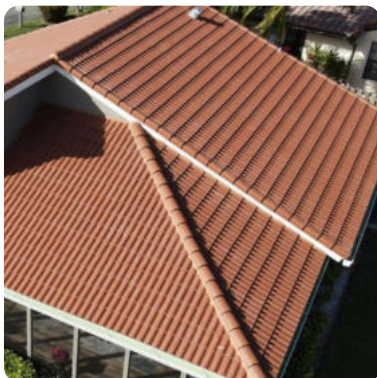
**Concrete/Clay Tile Shingle photo(s)**

| 4.1 Roof Covering Type: | Permit Application Date | FBC or MDC Product Approval # | Year of Original Installation or Replacement | No Information Provided for Compliance |
|---|---|---|---|---|
| <input checked="" type="checkbox"/> Concrete/Clay Tile | 06/15/2021 | DEMO-NOA-26-0905.01 | 2021 | <input type="checkbox"/> |

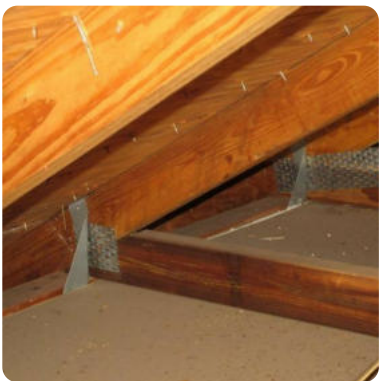
**Metal Connectors consisting of two (2) separate straps photo(s)**

- ☒ Metal Connectors consisting of two (2) separate straps, one on either side of the truss/rafter where each strap wraps over the truss/rafter and is secured with a minimum of two (2) nails on one side, and a minimum of one (1) nail on the opposing side, **OR**
- ☐ Metal connectors consisting of a single strap that wraps over the truss/rafter, are secured to the side of the wall and/or bottom of the top plate with a minimum of three (3) nails on each side, **OR**
- ☐ Purpose-made metal connector(s) or structural fastener(s) with a substantiated wind allowable uplift capacity of 891 lbs. or greater installed per the manufacturer's installation specifications (requires site-specific documentation).

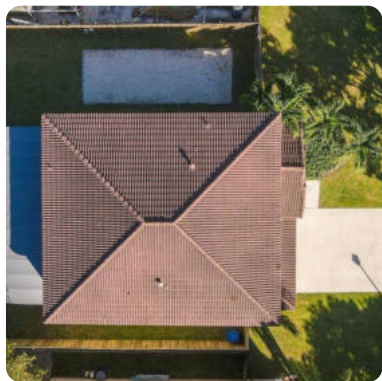
Roof Geometry photo(s)

☒ A. Hip Roof: Hip roof with no other roof shapes greater than 10% of the total roof system perimeter.  
Total length of non-hip features: 0 feet; Total roof system perimeter: 210 feet.

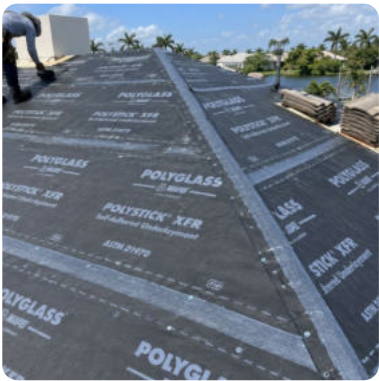
Sealed Roof Deck Photos(s)

☒ A. Sealed Roof Deck (also called SWR)

☒ Fully adhered polymer-modified bitumen roofing underlayment complying with ASTM D1970.

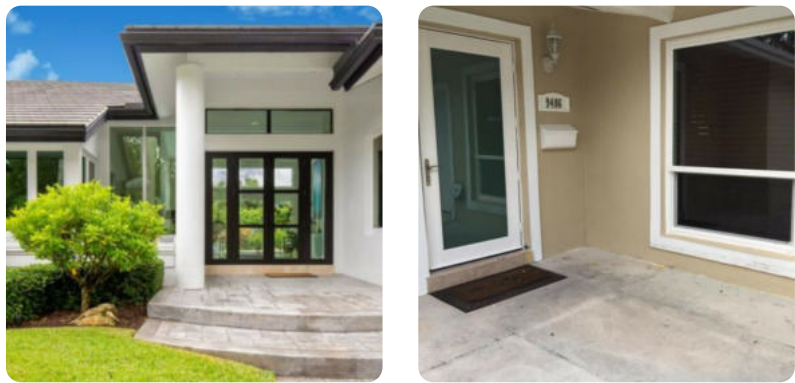
Windows or Entry Doors with Glass Photos

| Opening Protection Level Chart | | Glazed Openings | | | | Non-Glazed Openings | |
|---|---|---|---|---|---|---|---|
| A | Verified cyclic pressure & large missile (9 lb. for windows, doors/4.5 lb. for skylights) | X | X | | | X | X |

☒ **A. Exterior Openings Cyclic Pressure and 9-lb. Large Missile (4.5 lb. for skylights only):** All glazed openings are protected, at a minimum, with impact resistant coverings or products listed as wind borne debris protection devices in the product approval system of the State of Florida or Miami-Dade County and meet the requirements of one of the following for "Cyclic Pressure and Large Missile Impact" (Level A in the table above and Hurricane in the factor table).
