## Wood Destroying Insect Inspection Report

Report No. **2607010**

2575 Cambridge Road, East York, PA 17402

# Wood Destroying Insect Inspection Report

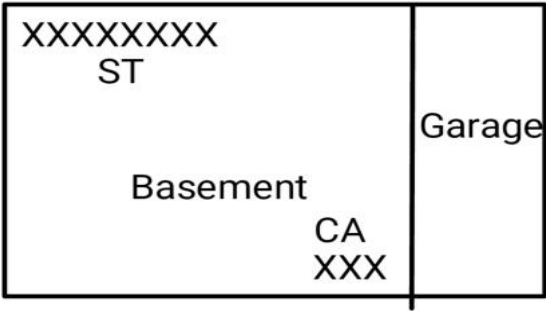
WOOD DESTROYING INSECT SKETCH & INFORMATION

Below is the property sketch *HOMECHek*®, has inspected. It is important to note that the sketch is not to exact scale. Indicate the following:

Type : Existing Damage (X)

Type : Subterranean Termite (ST)

Type : Carpenter Ants (CA)

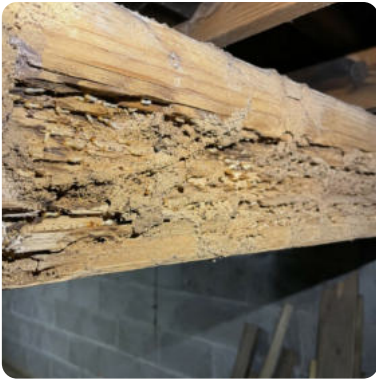
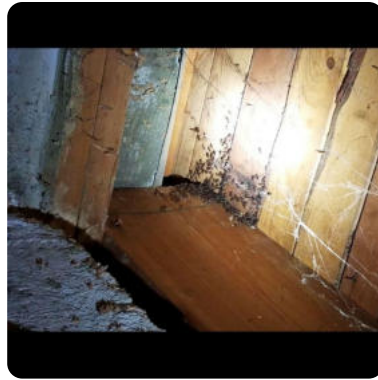
- Active termites found in basement. Active carpenter ants found in the Attic
- Active termite shelter tubes found in the basement. active carpenter ant frass found in the Attic
- Active termite damage found in basement beam and active carpenter ant damage found in attic plywood

Does Affect The Structural Integrity. The visible insect damage noted on the wood destroying insect sketch does appear to affect the structural integrity to the area where the damage was found in the structure. It is suggested to have a qualified specialist further evaluate and make corrections as needed.

The beam in the basement shows signs of termite damage that will require remedial repairs by a qualified specialist. Additionally, carpenter ant damage is present but is not significant and does not affect the structural integrity.
